# UNDERWATER BRIDGE INSPECTION REPORT

STRUCTURE NO. 3503

CHANNEL BETWEEN DETROIT LAKE AND DEAD SHOT BAY

DISTRICT 4 - BECKER COUNTY

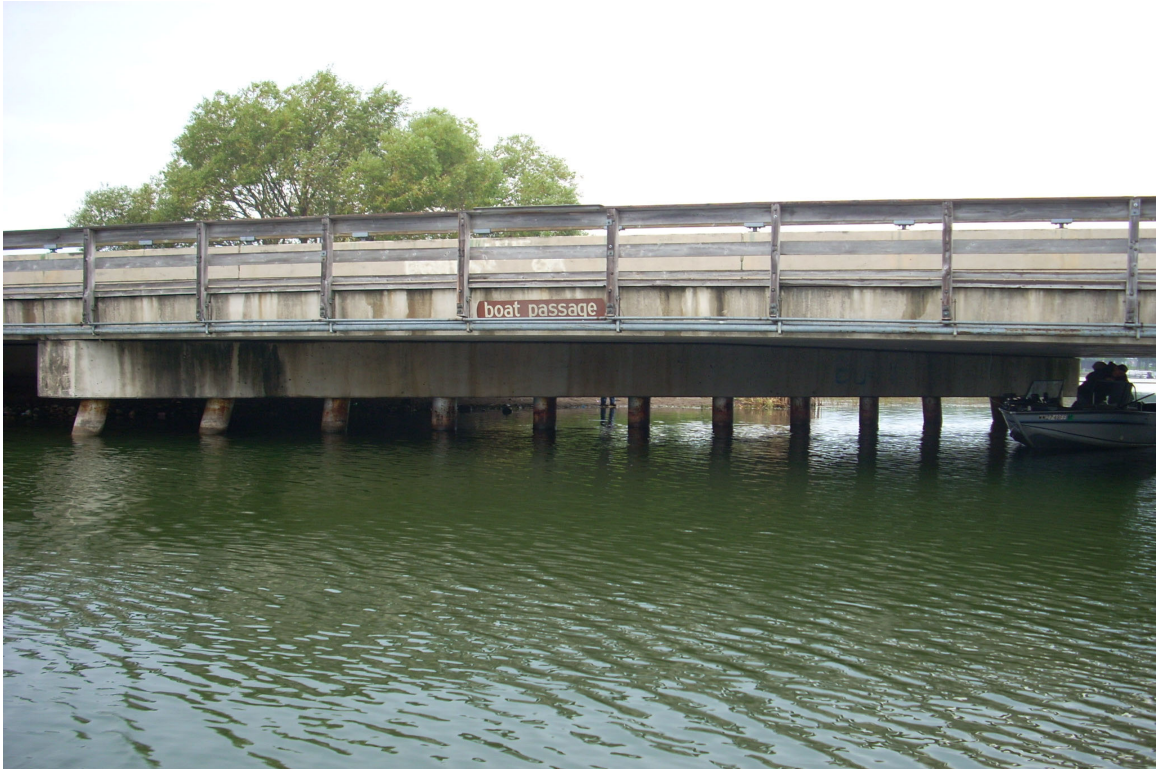
Photograph 1. View of Pier 1, Looking Southwest.

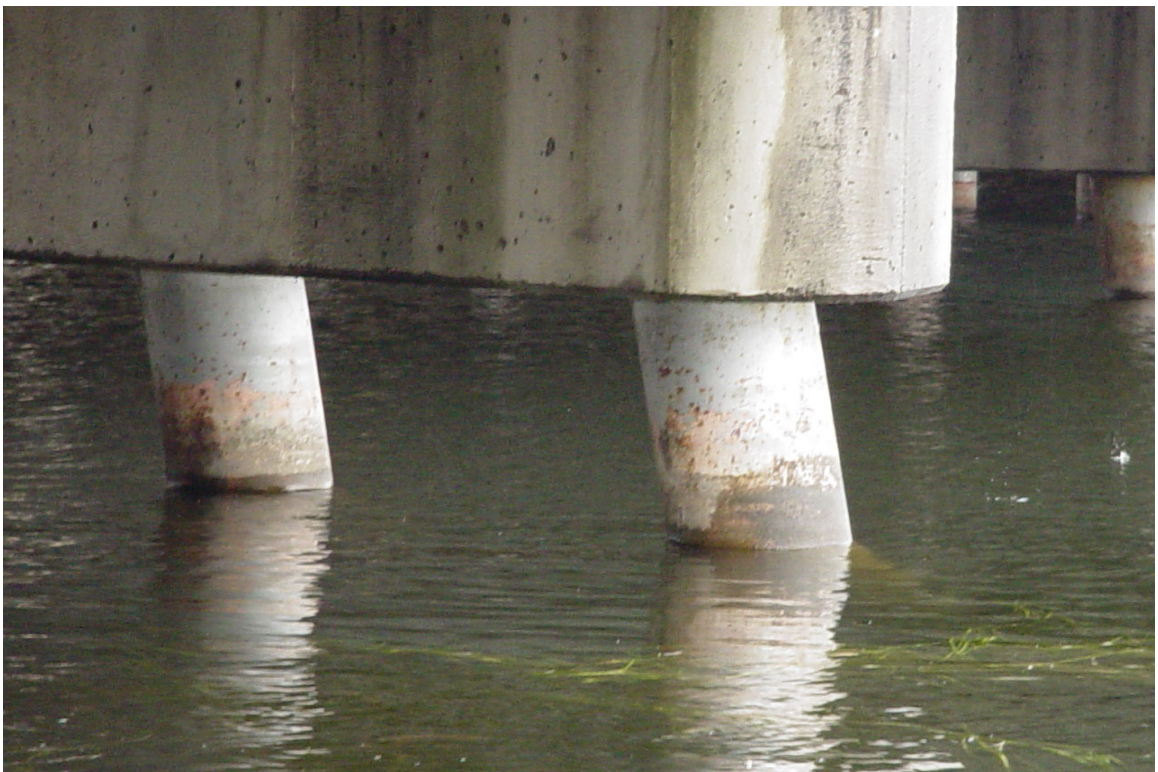
Photograph 2. View of Western End of Pier 1, Looking Southeast.

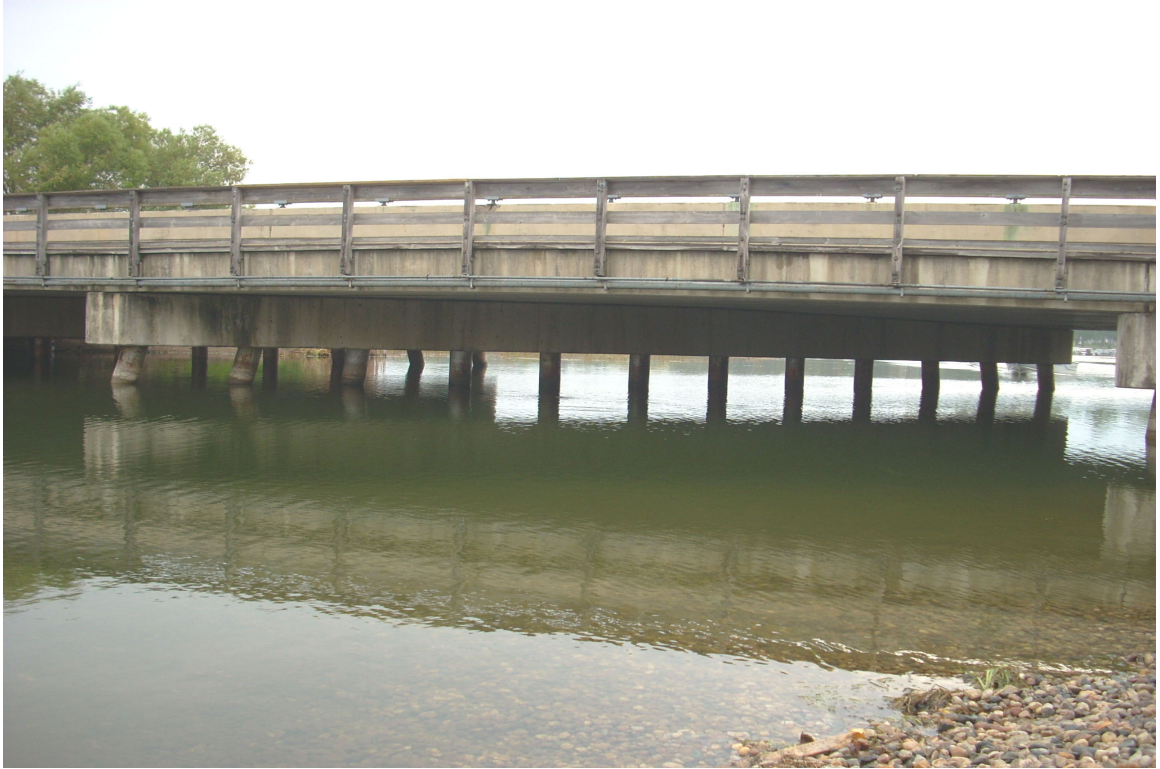
Photograph 3. View of Pier 2, Looking Southwest.

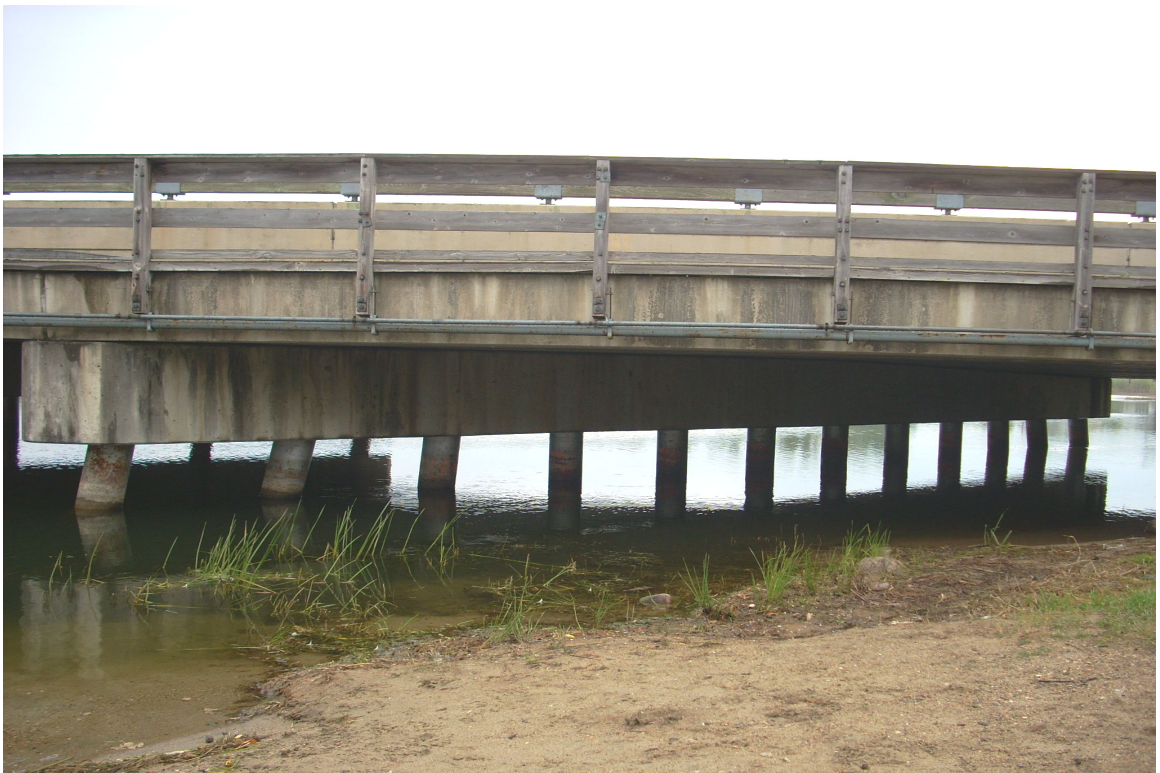
Photograph 4. View of Pier 3, Looking Southwest.

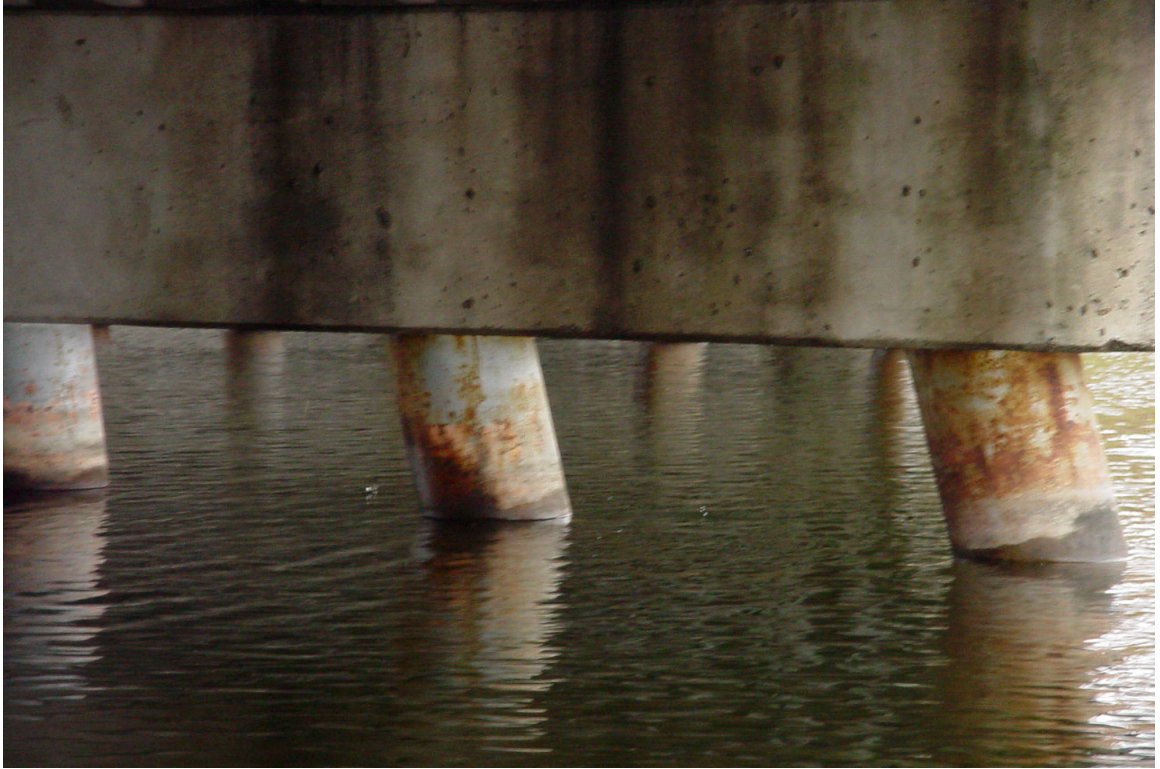
- (A) The protective coating on the cast-in-place steel pipe piles of all piers exhibited signs of initial breakdown from the top of the pile to the channel bottom.
- (B) Random rust nodules, 1/4 inch to 1 inch in diameter, were observed covering over 50 percent of the surface area of the piles from 10 feet below the waterline to the channel bottom, and over 10 to 20 percent of the surface area from the top of the pile to 10 feet below the waterline.
- (C) Timber debris, up to 12 inches in diameter, was observed scattered throughout the channel bottom at all of the piers.

Photograph 5. Typical Coating Failure on the Steel Pipe Piles.

- (A) Reinspect the submerged substructure units at the normal maximum recommended (NBIS) interval of five (5) years.

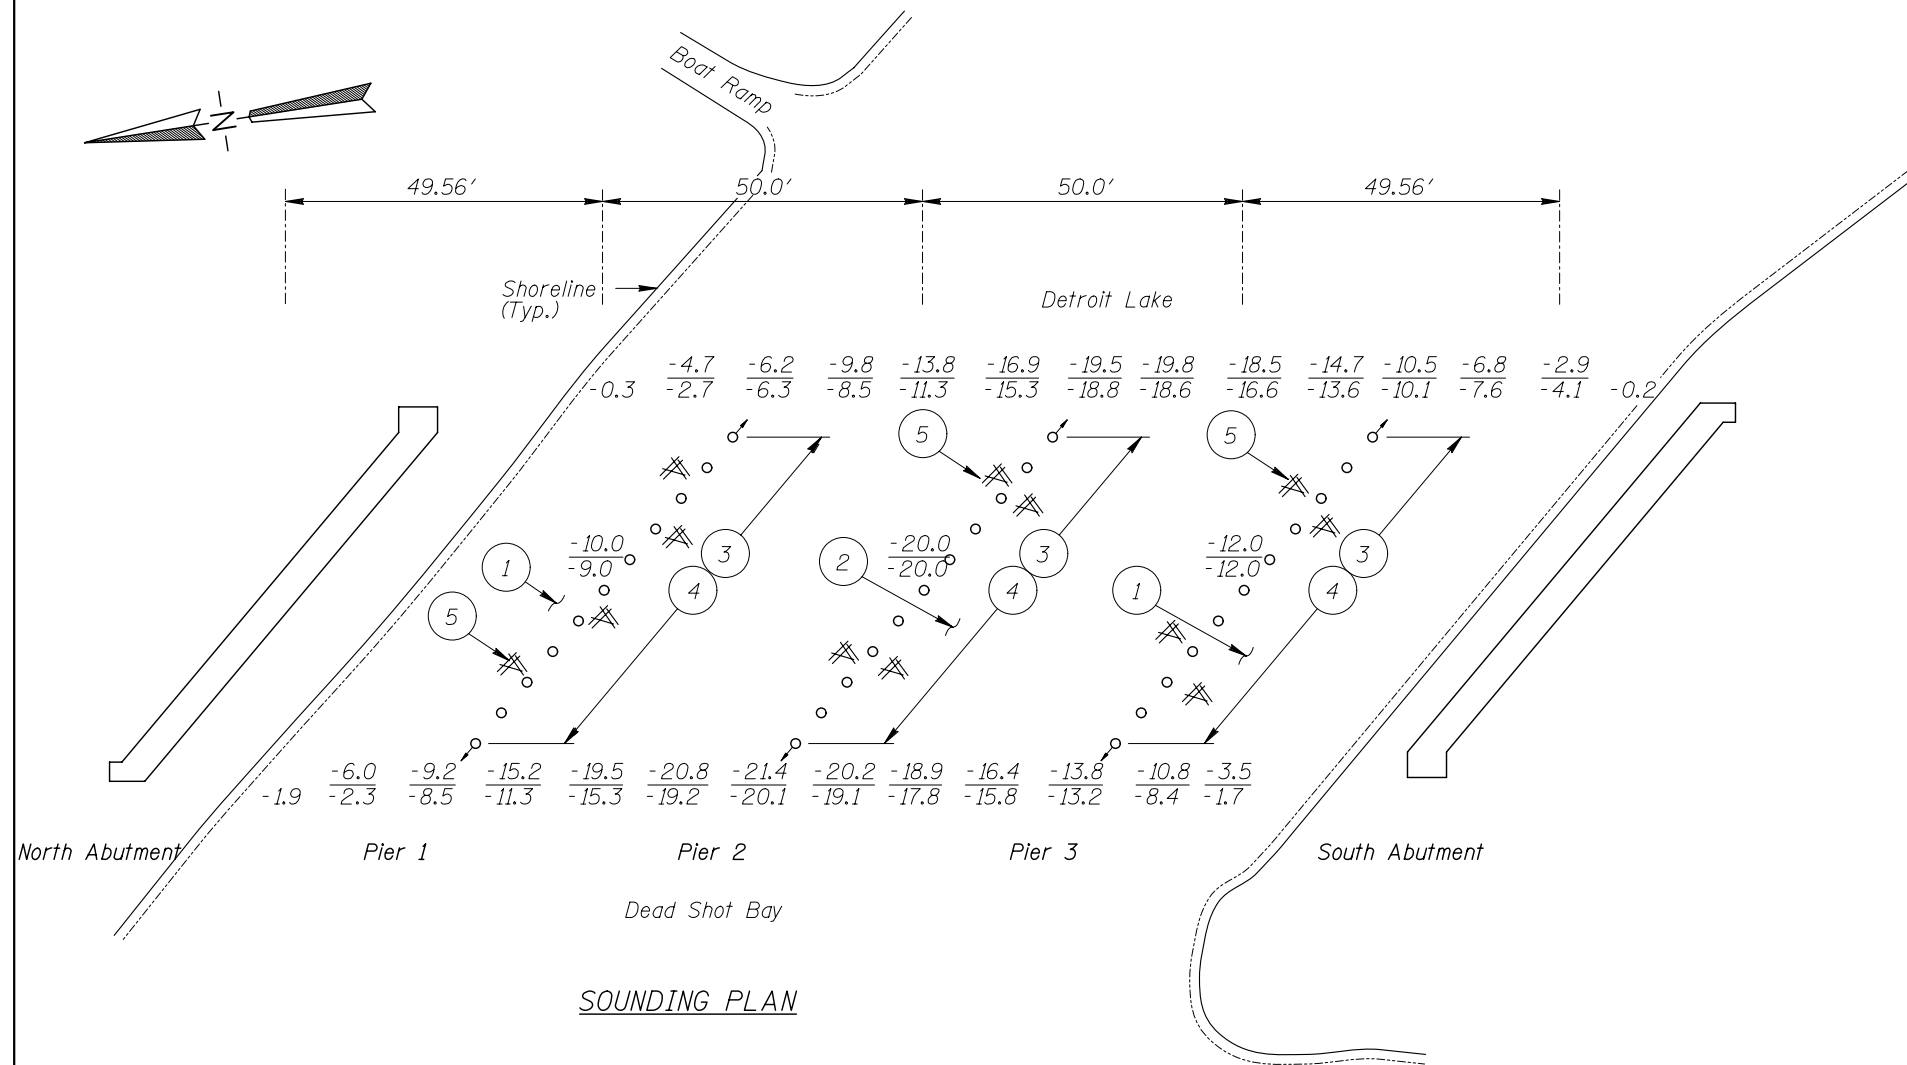
#### INSPECTION AND SOUNDING PLAN

- The channel bottom consisted of 6 inch diameter cobbles and sandy silt with up to 1 foot of probe rod penetration.
- The channel bottom consisted of sand with up to 6 inches of probe rod penetration.
- The steel pipe piles exhibited coating failure with light surface corrosion from top of pile to the channel bottom.
- The steel pipe piles exhibited rust nodules, typically 1/4 inch in diameter and up to 1 inch in diameter, over 50 percent of the surface area from 10 feet below the waterline to the channel bottom and over 10 to 20 percent from the top pile to 10 feet below the waterline. Associated pitting, 1/32 inch deep, was observed on all piles.
- Timber debris, consisting of logs up to 12 inches in diameter, was scattered throughout the piles of all the piers.
